BOULDER PARKS AND RECREATION Master Plan Update

INDOOR RECREATION FACILITY ASSESSMENT

September 20, 2012

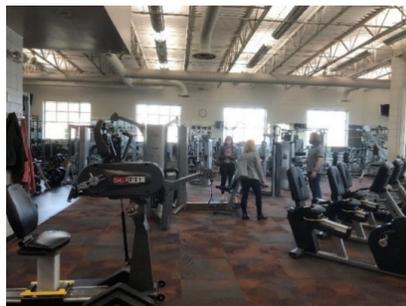
Fitness Area

FITNESS SPACES: The Facility Strategic plan noted that EBCC has the largest dedicated fitness area of Boulder's three recreation centers. Use levels vary by season, with winter use (pre-Covid) requiring a sign-up sheet for equipment, but staff confirm it is inadequate to meet year-round peak demand times. Customer requests include an enhanced functional fitness area, more cardio equipment, and an expanded free weight area. The climbing wall, tucked into the east corner of the fitness area, is underutilized, and generally limited to youth attending summer camp. While removal would minimally increase floorspace, the lowered floor and angular walls do not support a simple expansion of the fitness area. Staff confirmed to BRS that these space deficiencies persist.

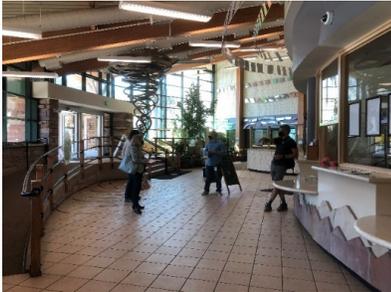
Entry / Reception Desk

The main entry is a large area with good sight lines but limited control. Customers and the public can enter with little engagement from front desk staff, particularly if entering along the accessible ramp. Re-imagining the front entry and creating an extended control desk that reaches out to greet people, may solve the issue of security while still supporting the openness desired.

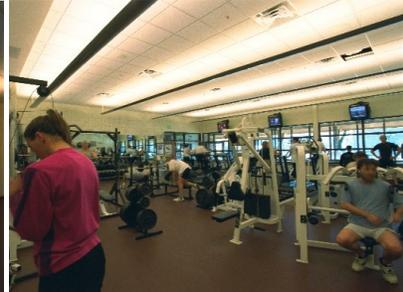
Weight Room

WEIGHT ROOM AND CARDIO: The capacity of the weight room and cardio area is inadequate. There is work currently under way to combine the space with the existing dance room. This will provide additional area for fitness equipment. At the time of our visit, machines were spaced for Covid-19 related social distancing requirements. The adequacy of the space will be better known once restrictions are lifted.

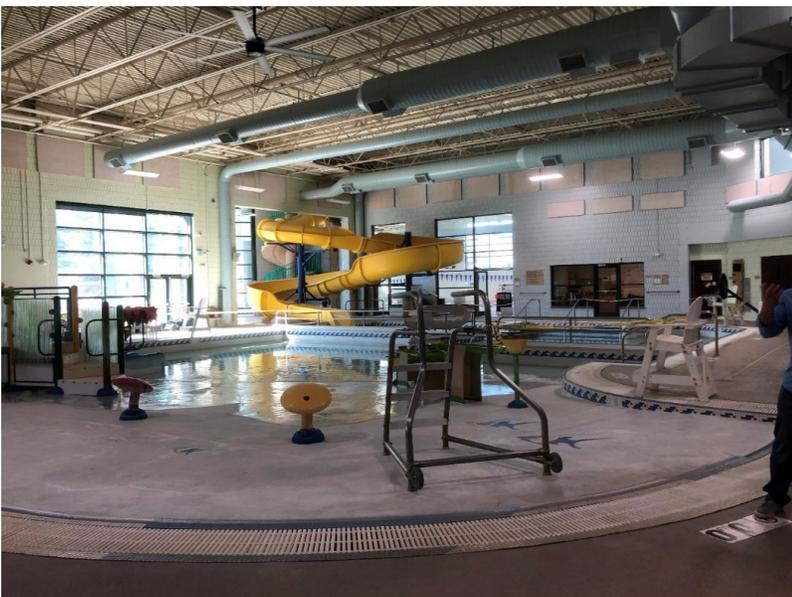
Leisure pool with zero-depth entry

The hot tub is tucked into the corner of the lap pool, requiring lifeguards be positioned to monitor its use. A blind spot exists between the slide and the windowed view into the lap pool, and must be continually checked for misuse when in operation. The garden-level sun patio receives little use. A sauna on the leisure pool deck is popular with pool users and can be a challenge for staff to manage its use and misuse.

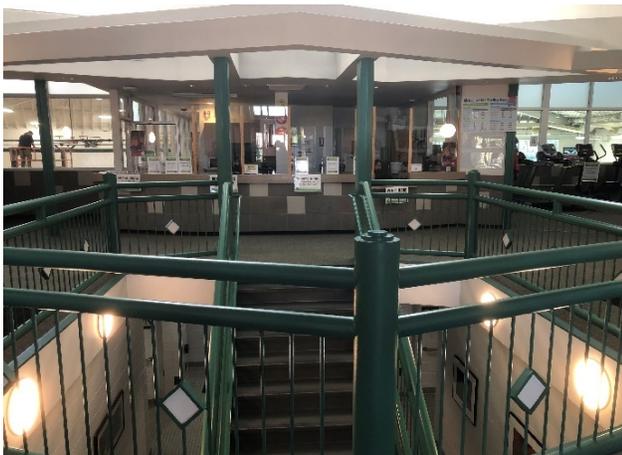
Entry / Main Stair

BRS Observations were limited to visual assessment of spaces, and ADA related compliance issues were not measured or verified as part of our work. The Facility Strategic plan completed in June 2016 evaluated ADA/Accessibility Issues. ADA requirements have not changed since then. It is worth noting again however, that in spite of efforts to meet the needs of all visitors, access is not fully realized. The elevator in the entry vestibule in particular does not meet the 'spirit' of ADA in that visitors must ask for access and a key. If a visitor found themselves on the lower level needing to use the elevator, the front desk can only be reached by the central stair.

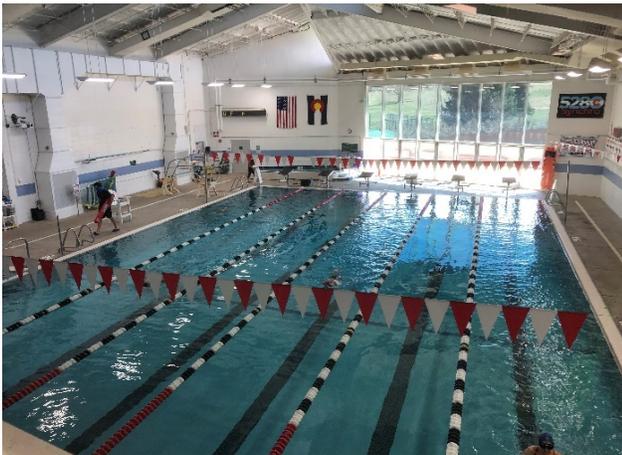
6 Lane Pool

WATER INFILTRATION: There are issues with water infiltration that appear to be related to the building’s proximity to the adjacent Viele Lake. The elevation of the adjacent lake water is said to be higher than the elevation of the recreation center’s gymnasium, racquetball court, aerobics room, locker rooms, and aquatics area. There have been past occurrences of water entering the building at the floor level of the racquetball court/ gymnasium. While BRS was on site, remediation work was being done in the racquetball court. Staff noted that water with a chlorine smell had damaged the floor such that it needed to be replaced. The smell of chlorine suggests the pool itself may be leaking, though no source has been found. The concrete masonry wall of the natatorium adjacent to Viele Lake is painted. The paint on this wall regularly spawls due to moisture infiltration and is repainted as part of regular maintenance cycles.

SBRC has served the Boulder community for nearly 50 years, a long-life for a recreation facility that has not seen significant financial re-investment. The HVAC system appears to be failing and pool water is infiltrating the lower level of the building. Poor circulation and lack of accessibility for differently abled individuals creates an exclusive facility. The front desk is not designed to sufficiently serve as a control point, creating security concerns for both customers and staff. Given these visible deficiencies, the city may explore anticipated costs to begin addressing them. However, the most economical path forward with a facility of this age is generally replacement rather than renovation. This presents an opportunity for the city to re-engage the community surrounding this long-standing resource and determine the appropriate needs and architectural program to serve them for the next 50 years.
